HARDENING OF ARMORED VEHICLE SUSPENSION COMPONENTS

HUBERT COMMINGE, MR.
US ARMY MOBILITY EQUIPMENT R&D COMMAND
FORT BELVOIR, VA 22060

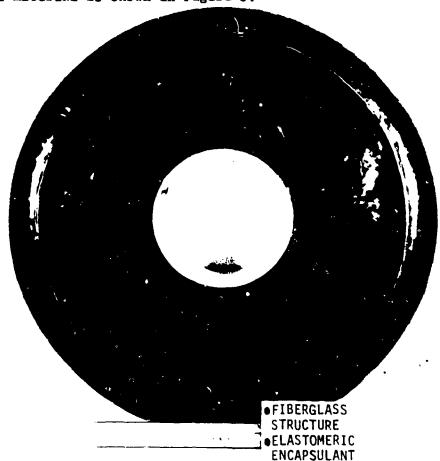
Figure 3. Mine-resistant tank roadwheel.

The hardened roadwheel internal structure consists of seven fiberglass radial support rings with an outer ring encapsulated in an elastomeric material as shown in Figure 3.

The mode of deformation for the roadwheel structure under load from an explosive blast occurs initially at the single point of tangency between the outer rim and one of the inner rings. As the explosive blast load is applied, both rim and inner ring deform so that the area of mutual contact increases continuously. Since rim-ring contact area increases continuously during loading, structural discontinuity does not occur at a single point and the large-velocity gradient is spread over a wider area minimizing and/or eliminating structural damage depending upon explosive charge size.
